Charles Street AME Church, Roxbury, MA

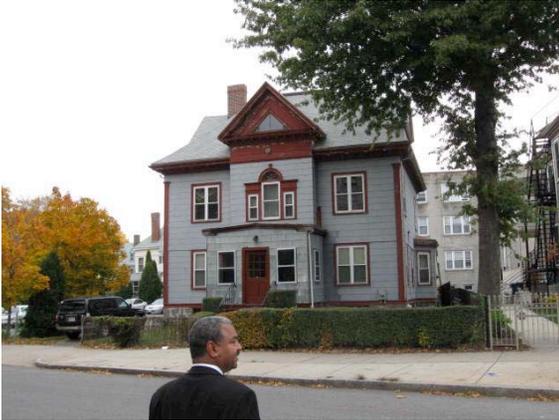
#1 — 5 Elm Hill Avenue is a 3 story + basement building, providing office, meeting and residential space.

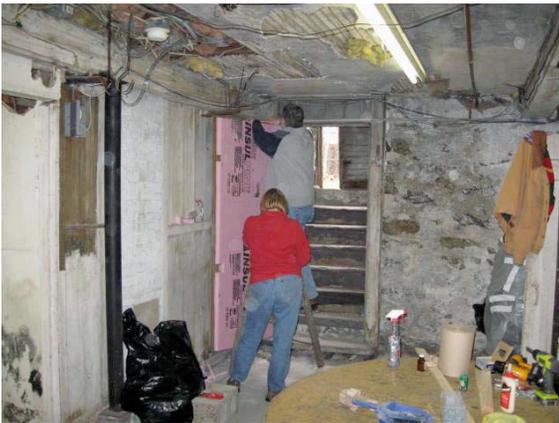
#2 — Wood hollow-core door with 1.5” rigid insulation added. “Great Stuff” foam insulation used to seal around frame and cracks in shed over stairs down. Basement ceiling had blown insulation some years back. The objective with insulation and caulking is to “fill every hole” so that cold stays outside in winter.

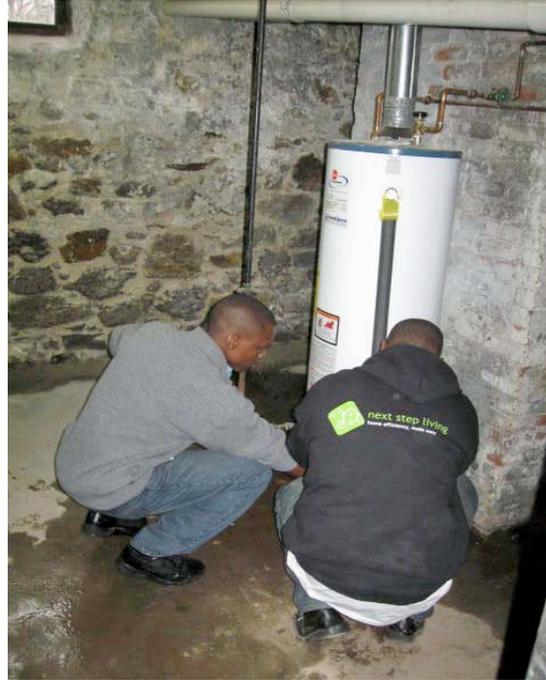
#3 — Gas-fired domestic hot water (“DHW”) tank having temperature setting lowered from HIGH to LOW. DHW was tested at the kitchen sink, and measured over 150°, which is scalding. Should be at 120°, or even less if being used for children such as at a Day Care Center. The temperature setting is an easily-understood dial, and can be adjusted by just about anybody. Setting lower – and installing low-flow aerators on faucets and low-flow showerheads — means less water and less DHW, so use reduce then cost\$ reduced. Adding an insulation blanket to the DHW tank can also help, even for newer DHW tanks which are better insulated than old.

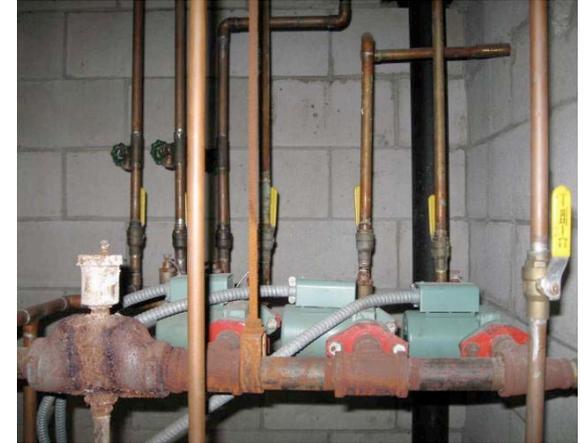
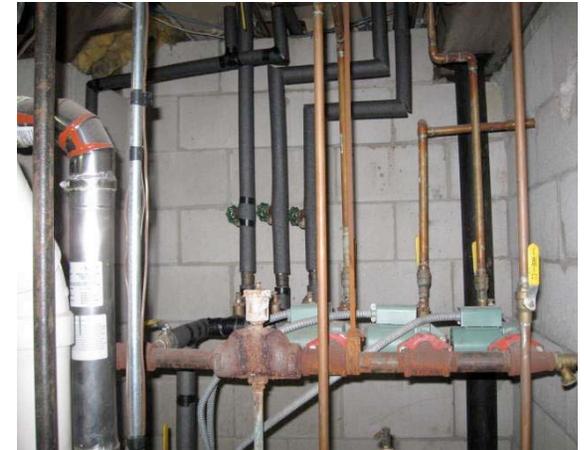
#4— Pipes over boiler before (above) and after (below). Insulate heating and DHW pipes in non-occupied spaces. Get heat and domestic hot water where the people are!

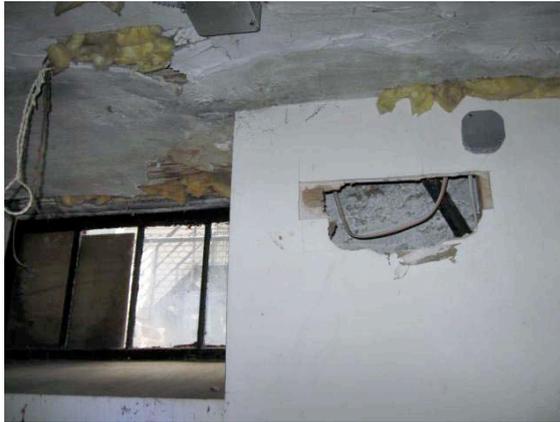
#5— All basement windows now have interior “storm” window installed. This significantly improves thermal performance is this large “hole” in the wall. The cracks and voids around the windows (and especially in the ceiling above) filled by spraying “Great Stuff” foam and adding fiberglass insulation.

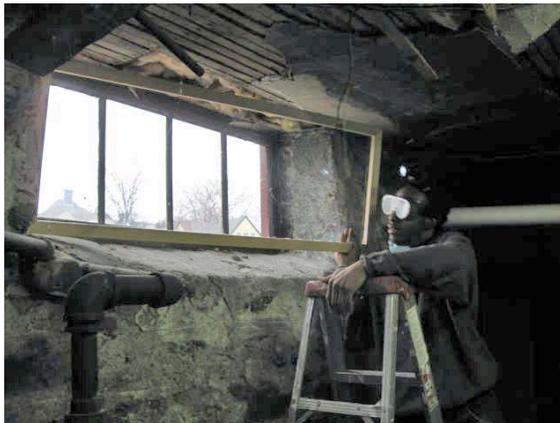
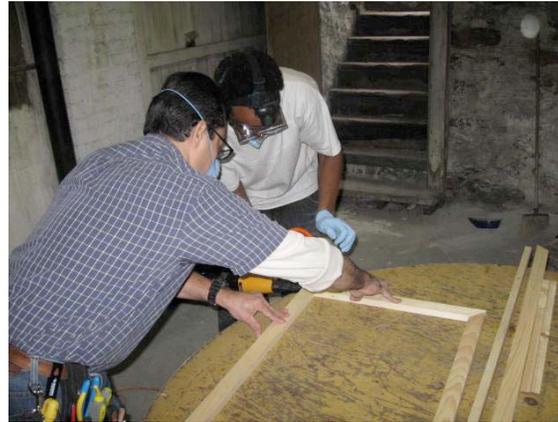
#6 —Interior “storm” windows are easy to make, and are light weight. Wood frame (above) is nailed together at corners. Plexiglas is cut to size at supplier. Measure carefully! It has blue wrap to keep saw dust and scratches off. Plexiglas is adhered to wood by glue and then screwed to frame. Weather stripping is then added around edge to create a good seal between this new storm window and existing window frame.

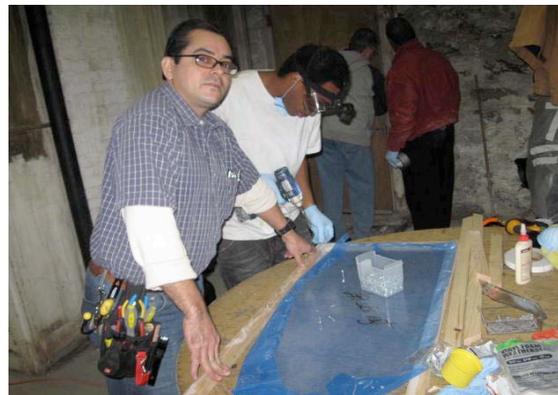
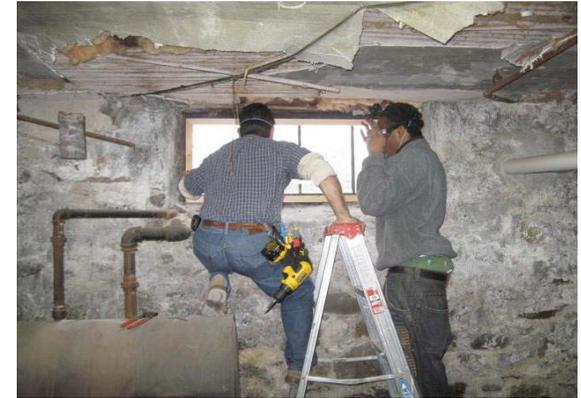
#7 — After pre-drilling holes for screws, attach window in existing window frame. Some interior “storm” windows (such as these) can stay year round. In occupied spaces where windows will be opened for circulate, remove in late-Spring and install again in mid-Fall. In occupied spaces “storms” should be painted to match window frame.

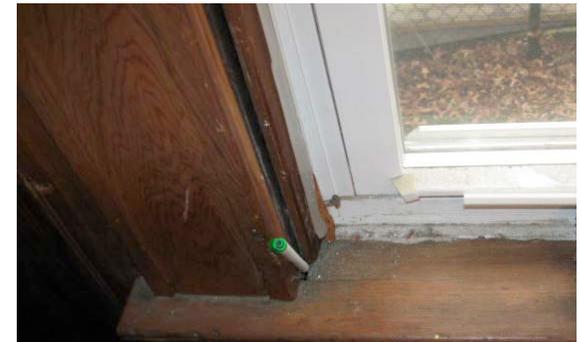
#8 — And more holes to fill, in upstairs rooms! If a pen can fit into one hole and there is a void all around, imagine how large the total “hole-in-the-wall” is!
